Inspection Report

Property Address:
124 Mockingbird Lane
Albany NY 12201

Altamont Superior Home Inspections LLC

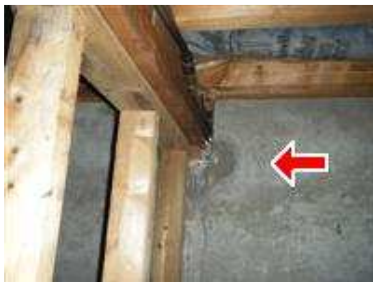
1.0 Picture 1

Evidence of water intrusion at beam pocket in basement. At this location on the exterior, there is a negative ground slope that directs water toward the foundation. Recommend improvement to exterior grading and use of drain tile to prevent this.

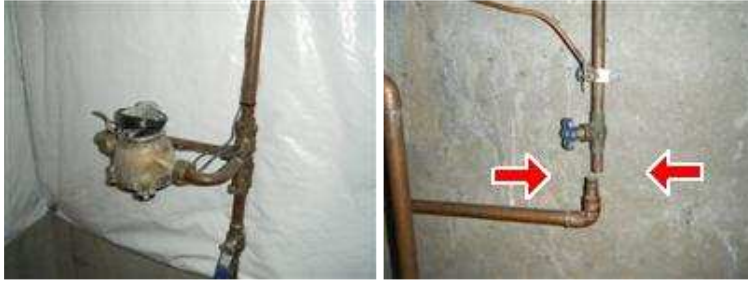
4.1 Picture 1

Water meter in basement has no jumper wire to maintain continuity of grounding. Also, there is a broken water pipe in the basement that needs repair before water is turned back on.

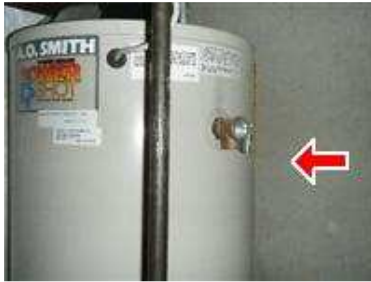
4.2 Picture 1

Water heater lacks a TPRV (temperature/pressure relief valve) extension. The purpose of the valve is to relieve pressure in the water tank if the temperature of the water becomes too high, making it expand. The extension tube directs the hot water and steam toward the floor, rather than into the air where someone could be injured. The tube should be made of 3/4" copper (not PVC) and extend to within 6 inches of the floor.

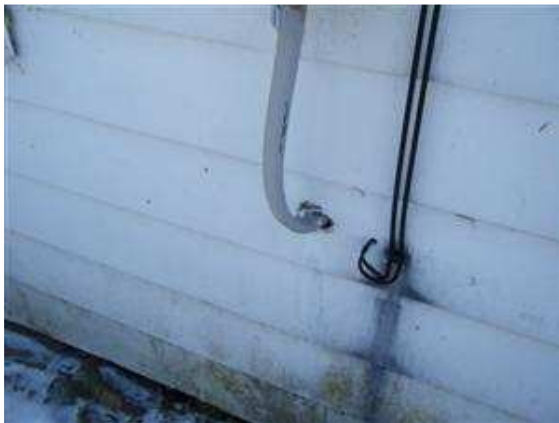
5.0 Picture 1

Service conductor is not properly secured to home at the exterior. Also, the entry point is not sealed properly, which could allow moisture to damage the sheathing and structural components. Recommend that these issues be addressed by a qualified contractor.

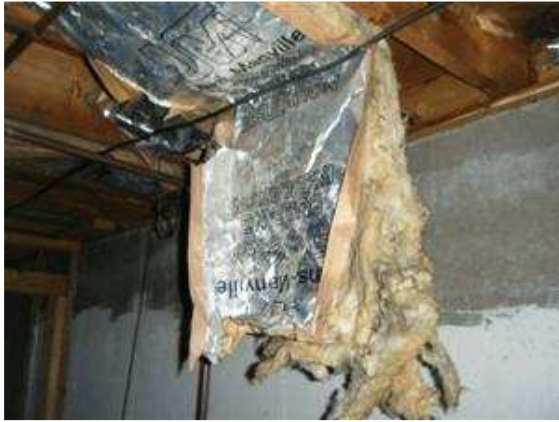
9.1 Picture 1

Fiberglass insulation in basement is in poor condition. Some areas are left un-insulated entirely. In some areas the insulation has been installed upside down, with the vapor barrier facing the unconditioned space.

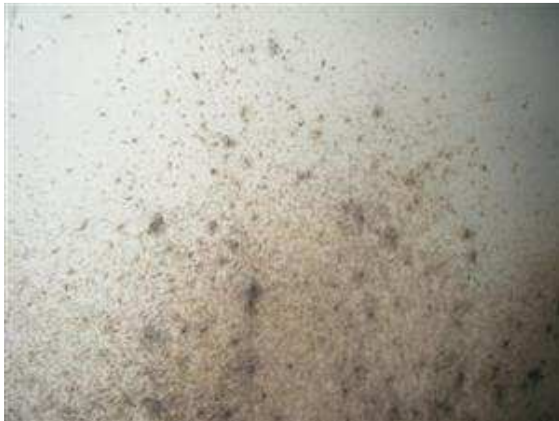
9.3 Picture 1

Basement has no source of ventilation, which may have contributed to this apparent mold growth in the basement. Recommend improving the basement ventilation to prevent humid air from stagnating in the basement. This causes condensation and leads to conditions favorable for mold growth. Also recommend mold testing and remediation of this area.

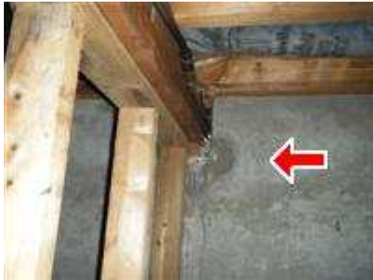
1.0 Picture 1

Evidence of water intrusion at beam pocket in basement. At this location on the exterior, there is a negative ground slope that directs water toward the foundation. Recommend improvement to exterior grading and use of drain tile to prevent this.

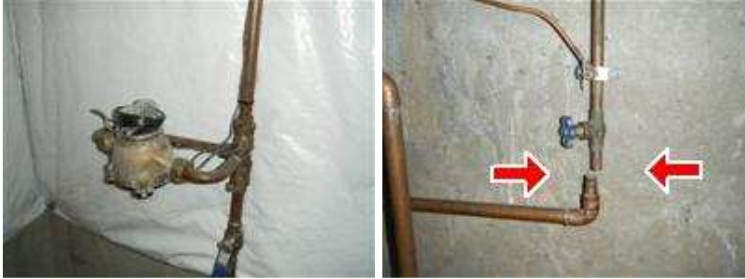
4.1 Picture 1

Water meter in basement has no jumper wire to maintain continuity of grounding. Also, there is a broken water pipe in the basement that needs repair before water is turned back on.

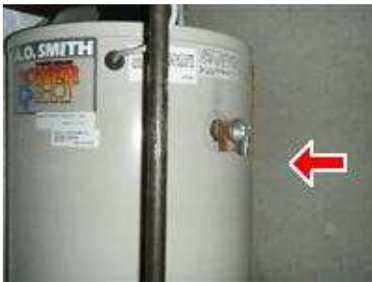
4.2 Picture 1

Water heater lacks a TPRV (temperature/pressure relief valve) extension. The purpose of the valve is to relieve pressure in the water tank if the temperature of the water becomes too high, making it expand. The extension tube directs the hot water and steam toward the floor, rather than into the air where someone could be injured. The tube should be made of 3/4" copper (not PVC) and extend to within 6 inches of the floor.

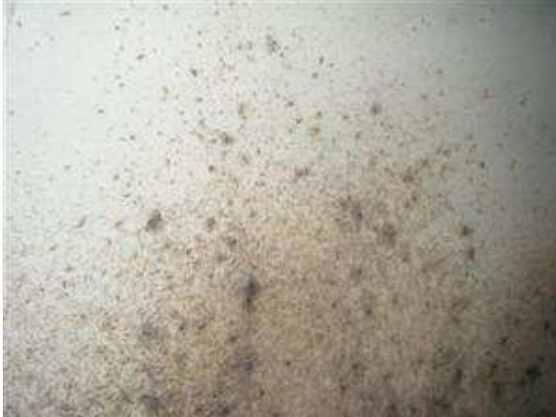
9.3 Picture 1

Basement has no source of ventilation, which may have contributed to this apparent mold growth in the basement. Recommend improving the basement ventilation to prevent humid air from stagnating in the basement. This causes condensation and leads to conditions favorable for mold growth. Also recommend mold testing and remediation of this area.

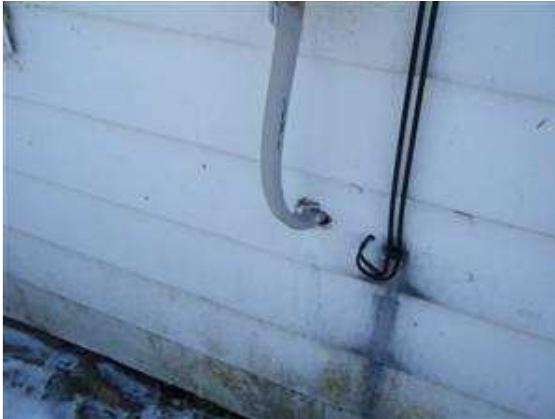
5.0 Picture 1

Service conductor is not properly secured to home at the exterior. Also, the entry point is not sealed properly, which could allow moisture to damage the sheathing and structural components. Recommend that these issues be addressed by a qualified contractor.

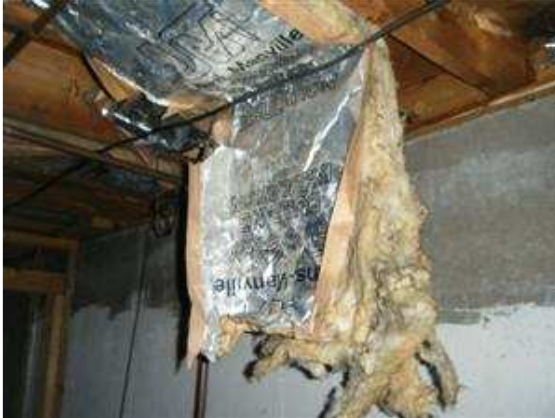
9.1 Picture 1

Fiberglass insulation in basement is in poor condition. Some areas are left un-insulated entirely. In some areas the insulation has been installed upside down, with the vapor barrier facing the unconditioned space.

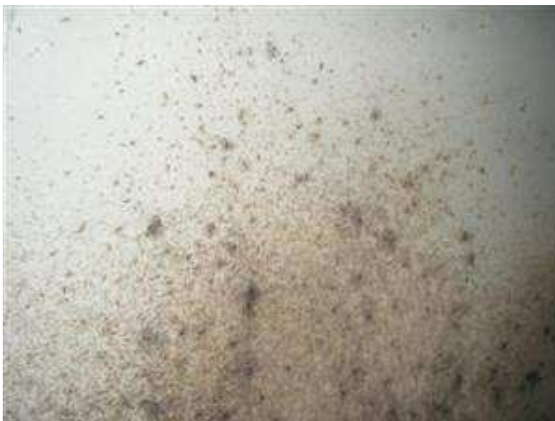
9.3 Picture 1

Basement has no source of ventilation, which may have contributed to this apparent mold growth in the basement. Recommend improving the basement ventilation to prevent humid air from stagnating in the basement. This causes condensation and leads to conditions favorable for mold growth. Also recommend mold testing and remediation of this area.
